AVIATION INVESTIGATION REPORT

A01P0111

AIR PROXIMITY—SAFETY NOT ASSURED

12 MAY 2001

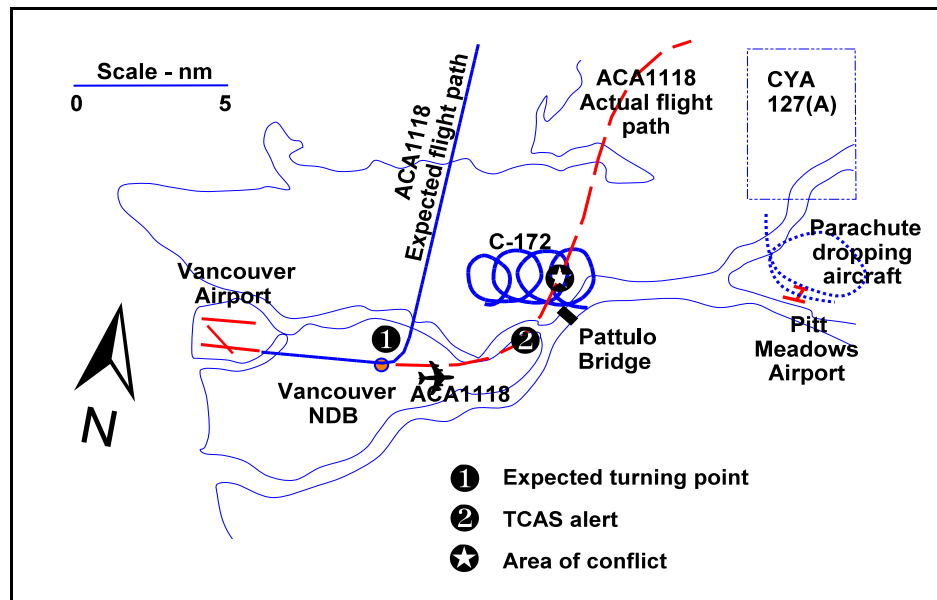
Figure 1 - ACA1118 flight path

The departure controller's first ATC instruction was at 1641:41 Pacific daylight time¹ for ACA1118 to turn to a heading of 360° for traffic when reaching 3000 feet. (See Appendix A for a chronology of the events.) The pilot correctly acknowledged this instruction. However, the A320 did not begin to turn north where the controller had anticipated—near the NDB—and the controller recognized a developing traffic conflict. At 1642:16, he instructed the A320 to turn further left to 350°, which the pilot acknowledged. About 15 seconds after passing 3000 feet,

about 2.5 nm past the NDB, the A320 began to turn left, to the north. At 1642:30, the controller informed the Cessna pilot about the conflicting A320 traffic. At no time did the Cessna pilot see the approaching A320.

Radar data show that ACA1118 was in a gradual left turn until it passed the Cessna; the aircraft's track was no farther west than 358°. ATC information confirms that the A320 had not yet turned to 350°.
